# Mid-MN Property Services LLC

## Home Inspection Report

Inspected on Thu, Jun 11 2026 at

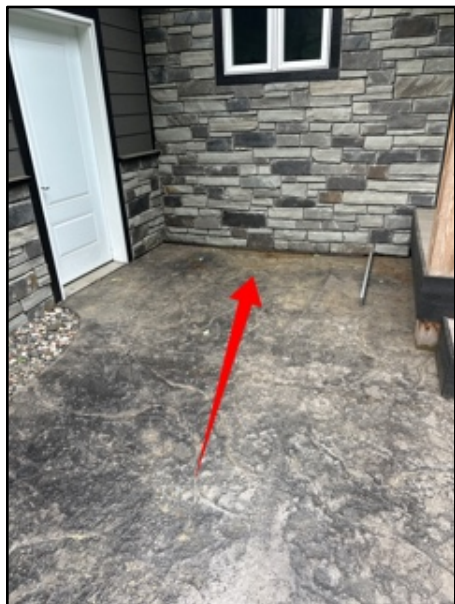
Figure 1-1

1) Slight negative grade at front patio/walkway toward house. This area may be prone to puddling water and ice buildup.

Possible Long term foundation concerns.

Slight negative grade at front patio/walkway toward house. This area may be prone to puddling water and ice buildup.

Recommend steps to mitigate water pooling; keep gutters clear, shovel snow and clear ice promptly.

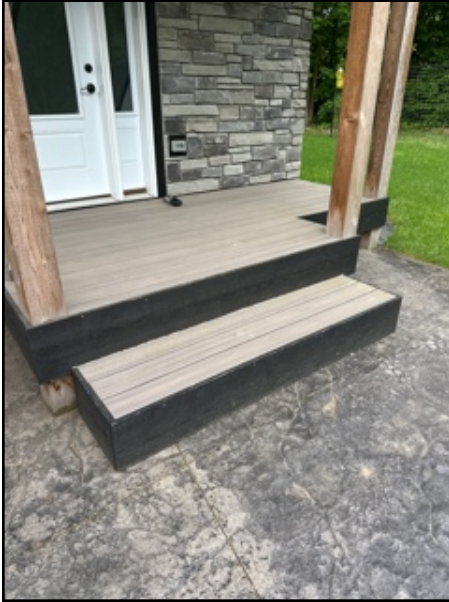
Figure 2-1

Apron/skirt board is natural wood. Installed flush to deck surface. This will be a high wear area and requires regular maintenance. Also tall step height may be trip hazard.

Note\* no visible frost footing. Seller states that footings are in place beneath slab.

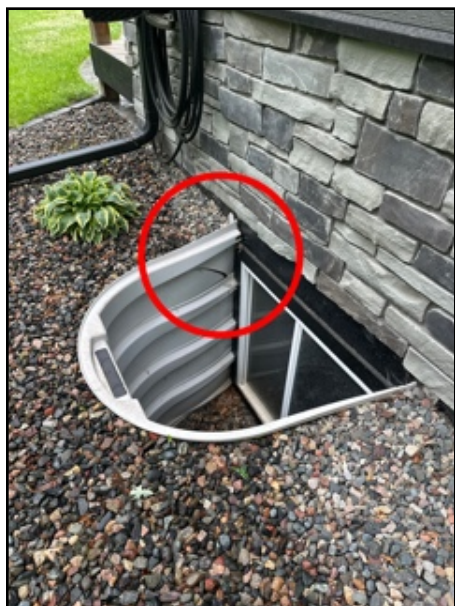
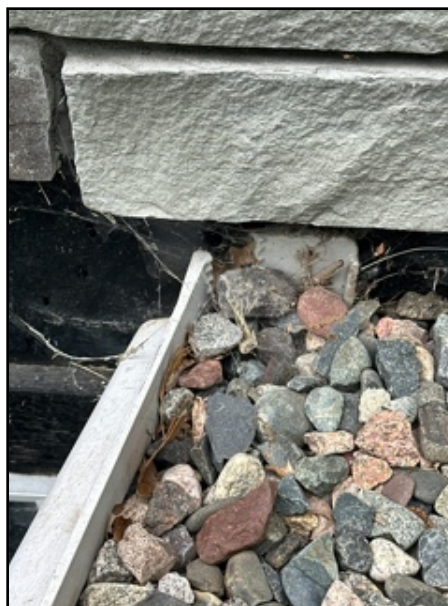
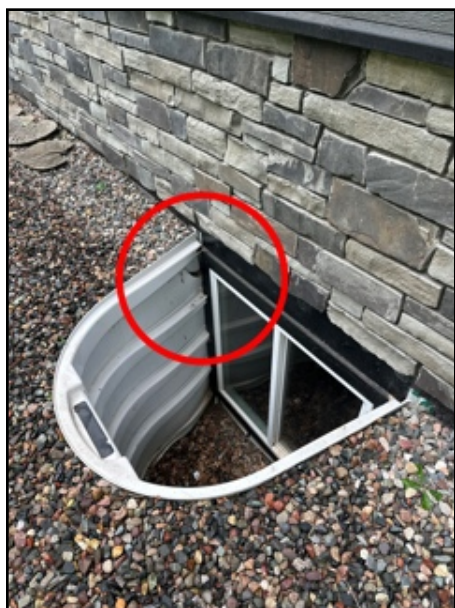
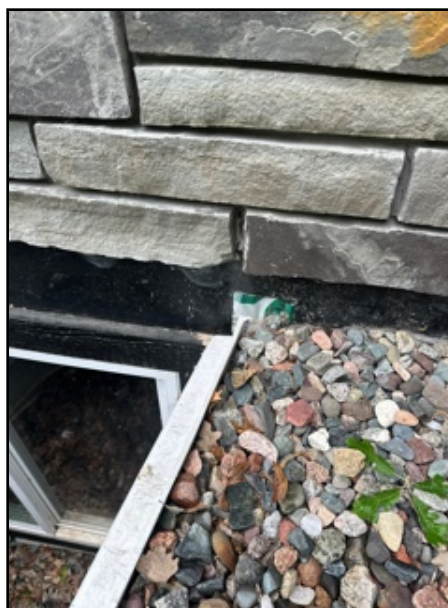
2) Top section of egress window wells are cracked.

Top section of egress window wells are cracked.

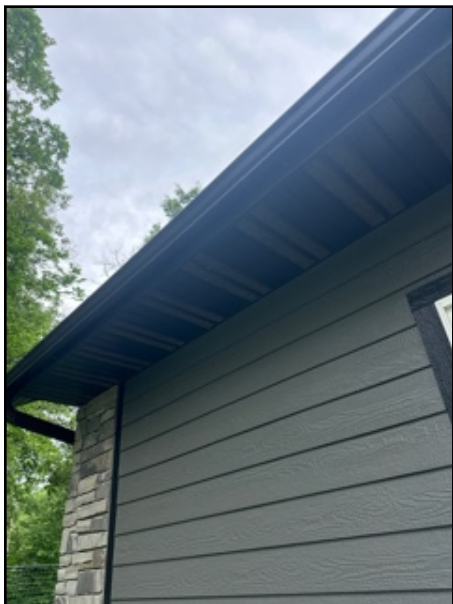
Figure 4-1

Soffit ventilation is abnormally clogged with dust buildup. Recommend cleaning and blow out and monitor for future issues

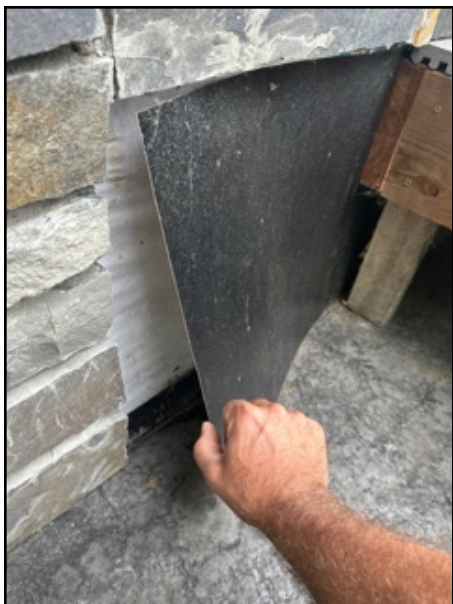
Figure 5-1

Aluminum trim not properly attached .

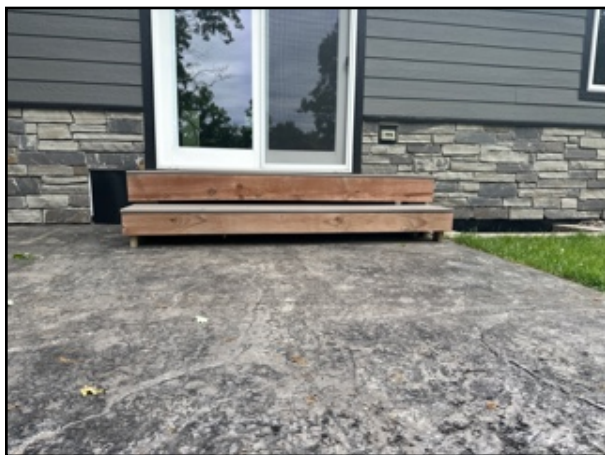
Figure 6-1

Back stoop:

Top rim joist warped.

Decking is not properly attached to framing.

Riser heights are taller than recommended.

Attached to house with no visible frost footing.\*seller states footings are in place beneath slab

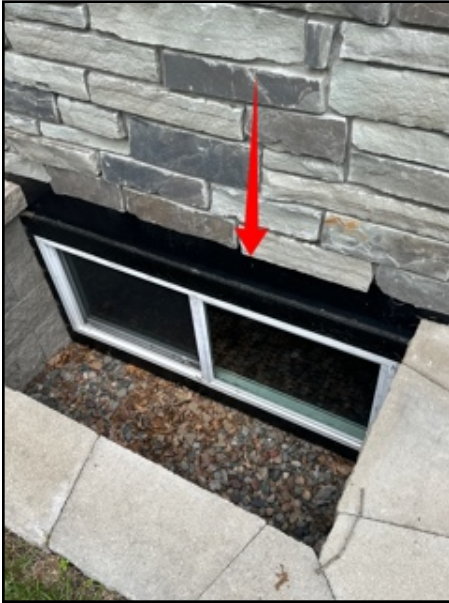
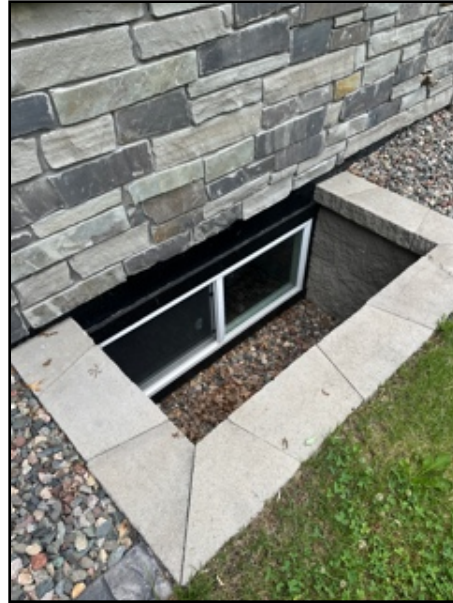
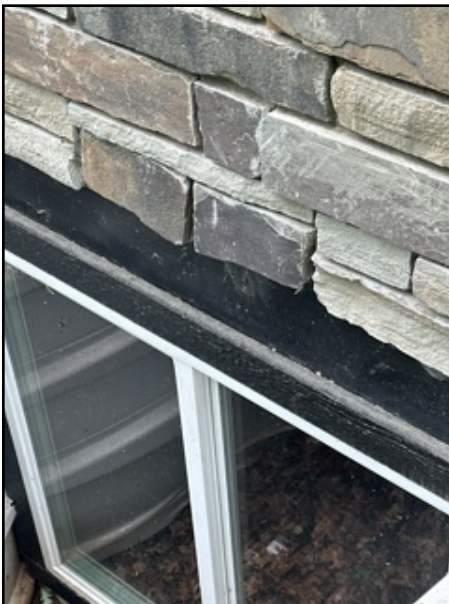
Comment 7:  
Drip protection missing at top of basement windows.

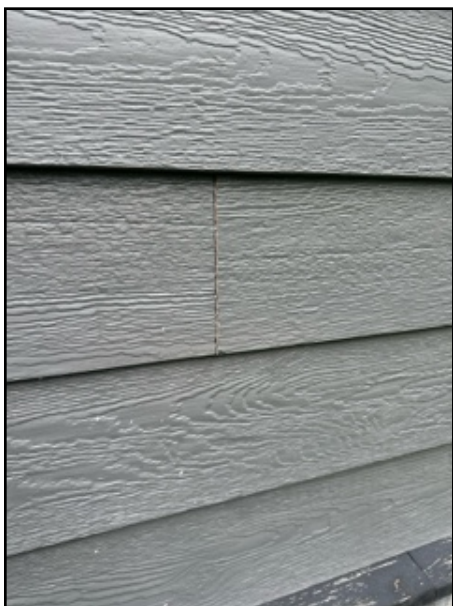
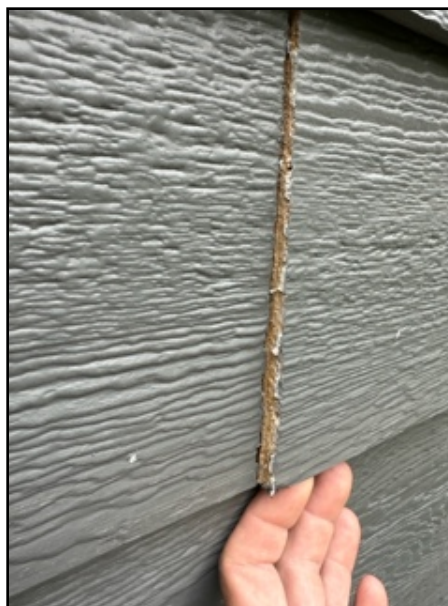
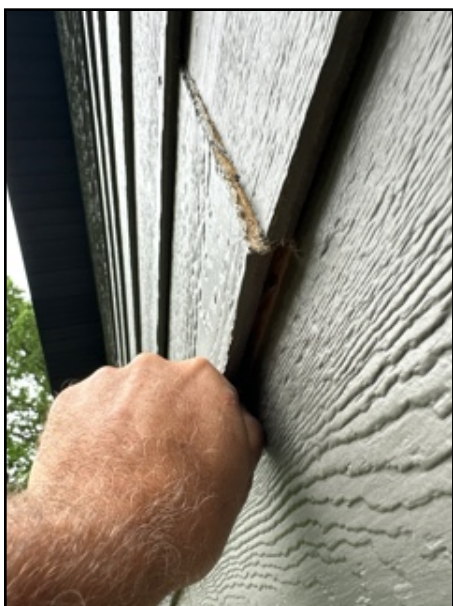
4) Siding seams not properly sealed, Unprotected edges will eventually take water damage and swell.

Some siding pieces are fairly loose which may be susceptible to damage in high winds.

Siding seams not properly sealed, Unprotected edges will eventually take water damage and swell.

Recommend addressing these items for long term durability.

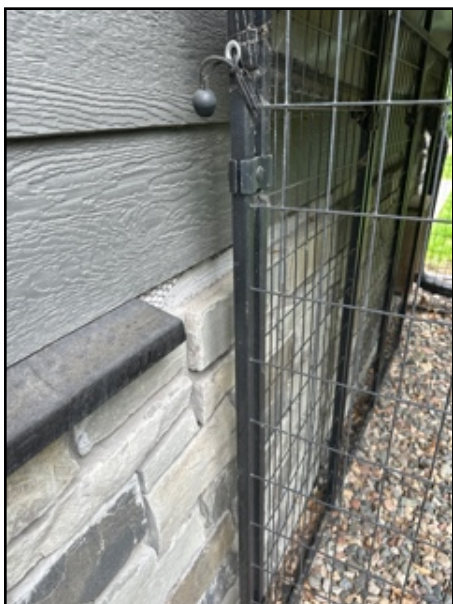
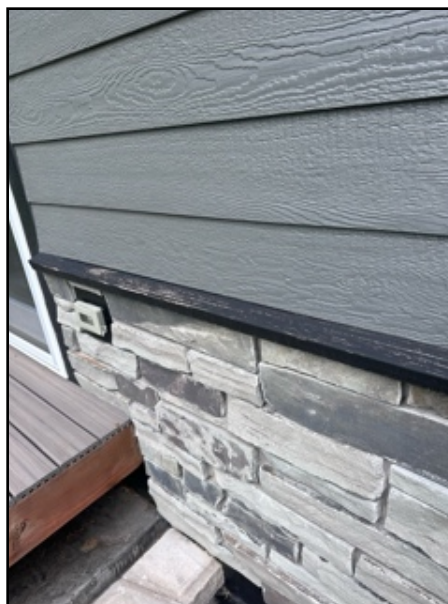
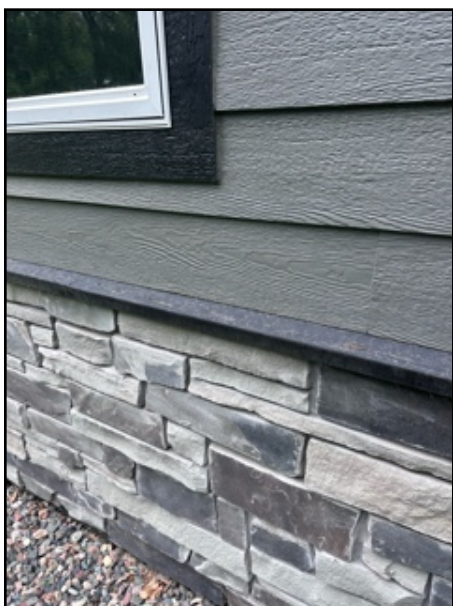
5) Missing water table trim board. This highlights improper installation details and missing flashing. Trim board is painted but is already showing wear in several areas. Consider durable flashing/wrap and gap along bottom edge of siding

Missing water table trim board. This highlights improper installation details and missing flashing. Trim board is painted but is already showing wear in several areas. Consider durable flashing/wrap and gap along bottom edge of siding

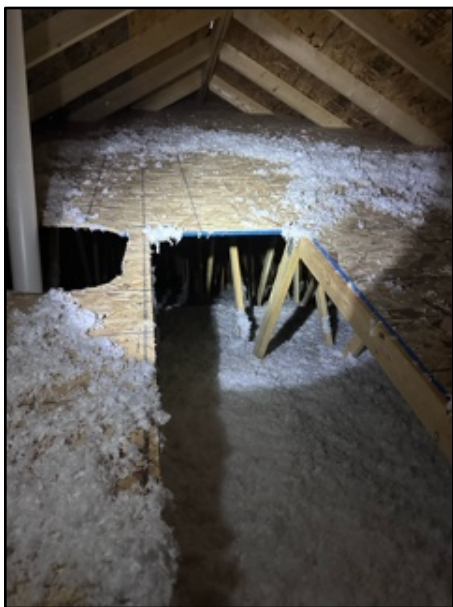
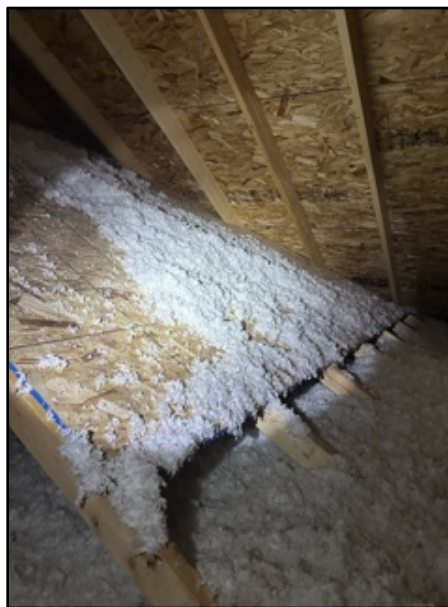
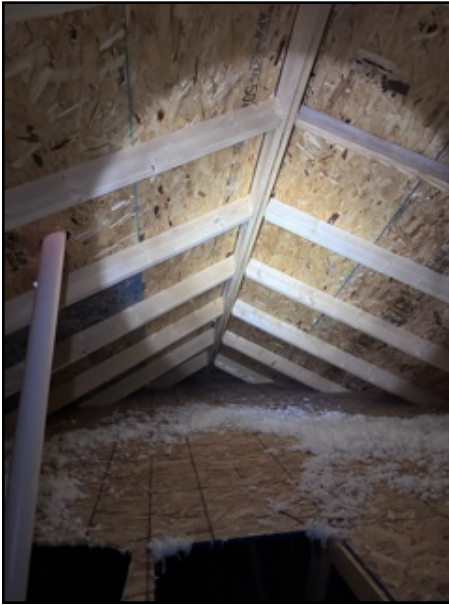
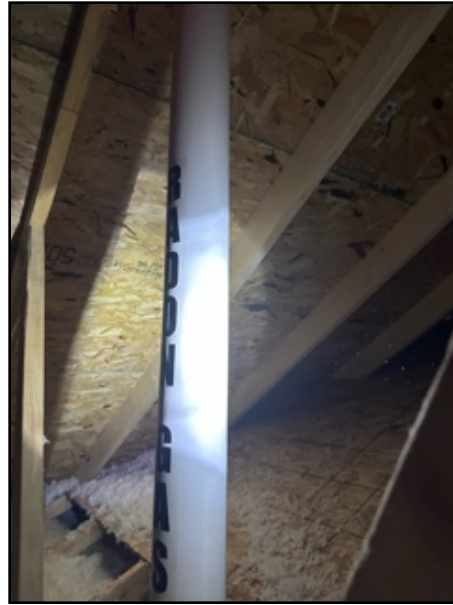
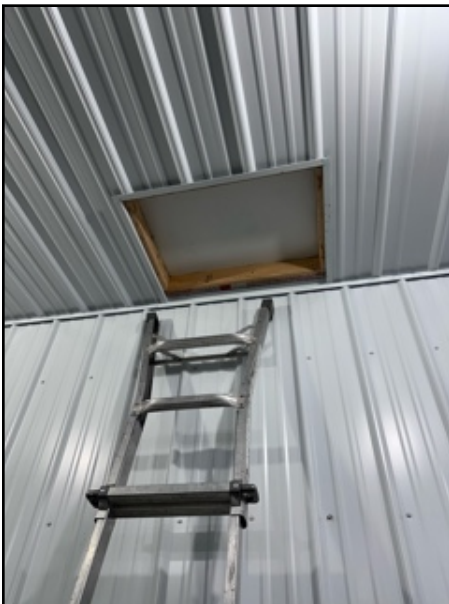
Insulation is blown in fiberglass that appears inconsistent with measurements of 10-14" taken and areas that may be over 16".

Access is difficult.

Opening should be finished in durable material to provide some flame spread protection.

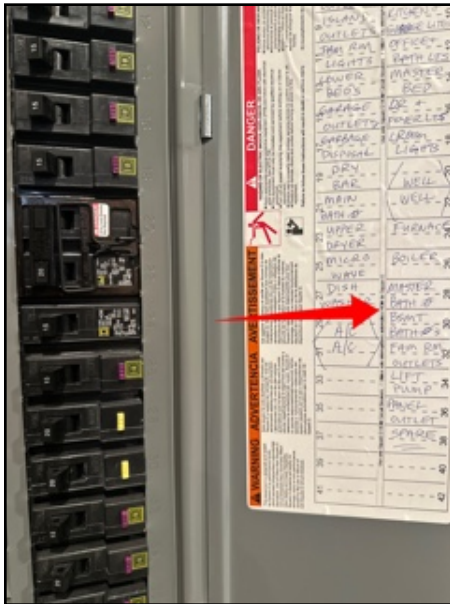
Figure 13-1

Comment 13:  
Basement and master bathroom breakers are reversed .

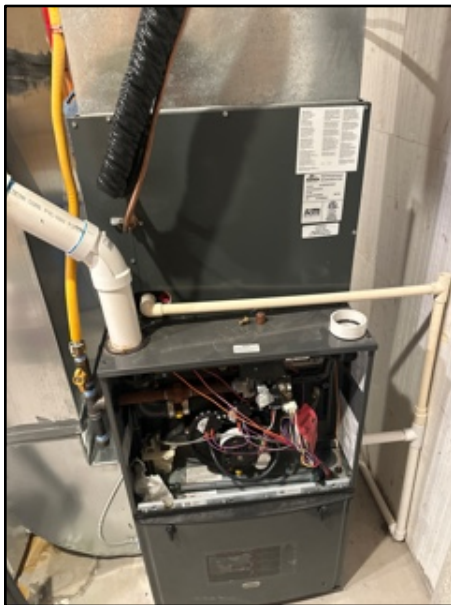
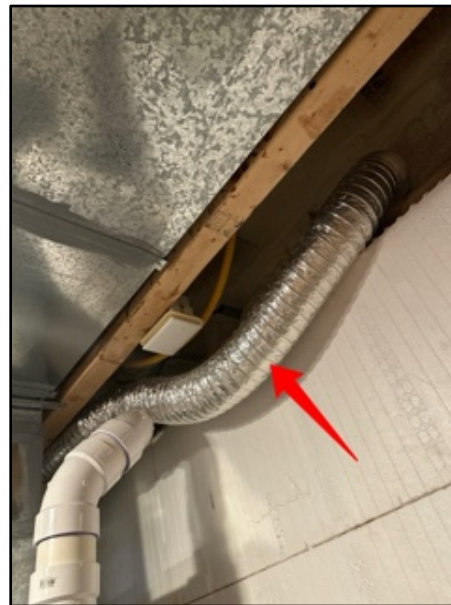
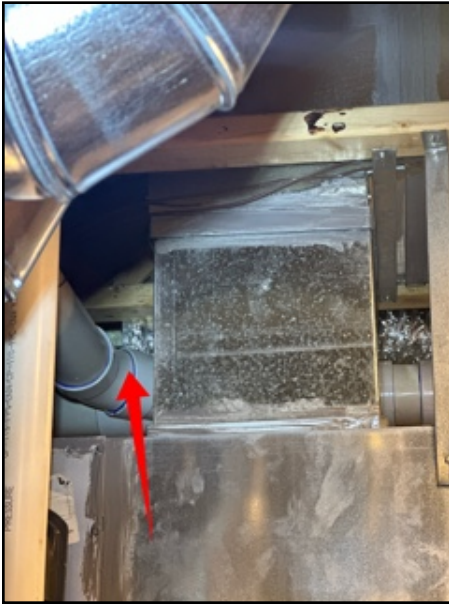
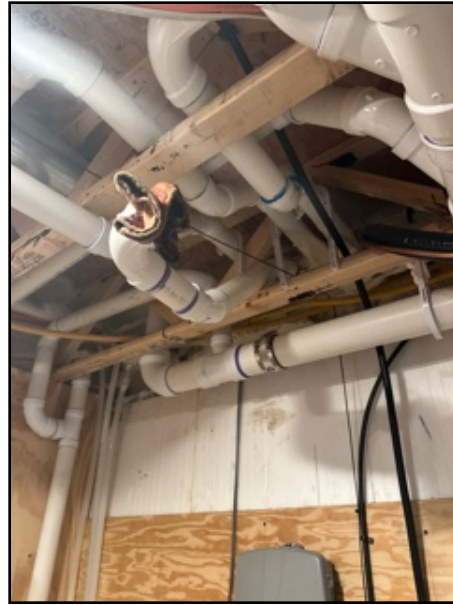
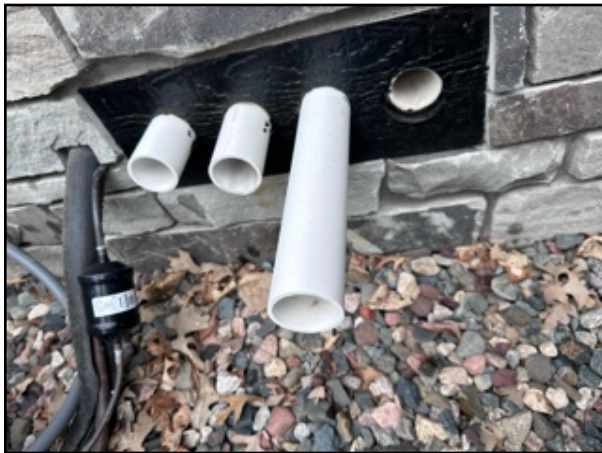
Furnace Intake not plumbed to outdoors .

Makeup air inlet is uninsulated and improperly terminated.

\*correction: 4" vent shown is stated to be intended as dryer vent. No makeup air present. Recommend add makeup air or connect furnace intake to outdoors and be sure intakes and exhaust terminations are properly separated from one another.

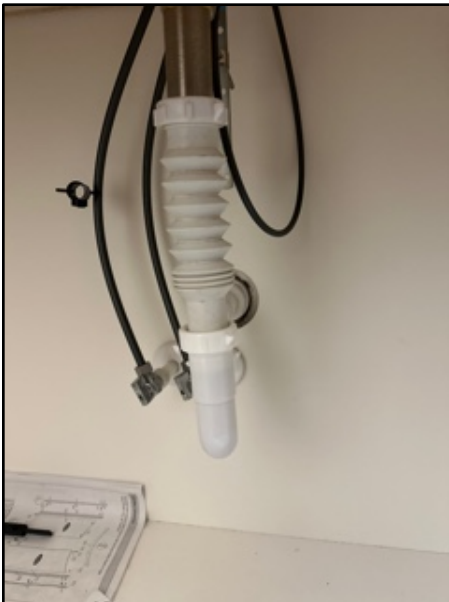
Figure 18-1

Drain pipe under sink is a flexible type that is not recommended for permanent use due to the tendency to clog and fail and/or crack.

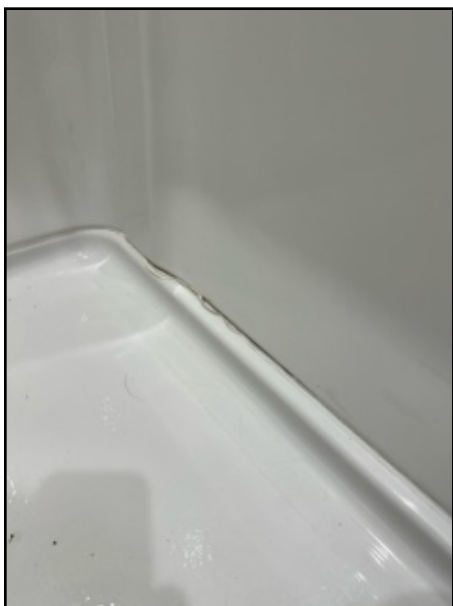
Figure 19-1

Comment 19:  
Caulk in shower due for replacement .

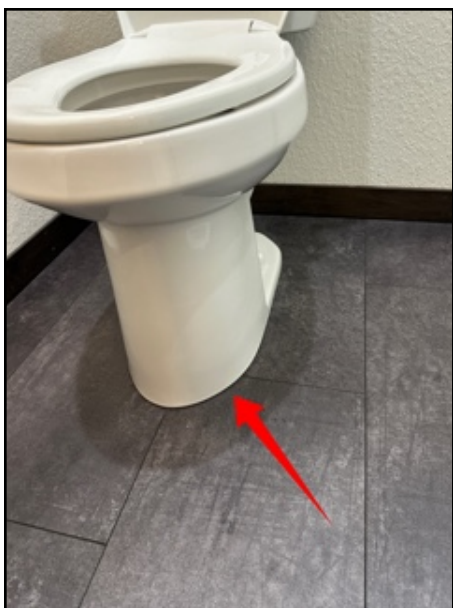
Figure 20-1

Comment 20:  
Toilet should be caulked around base.

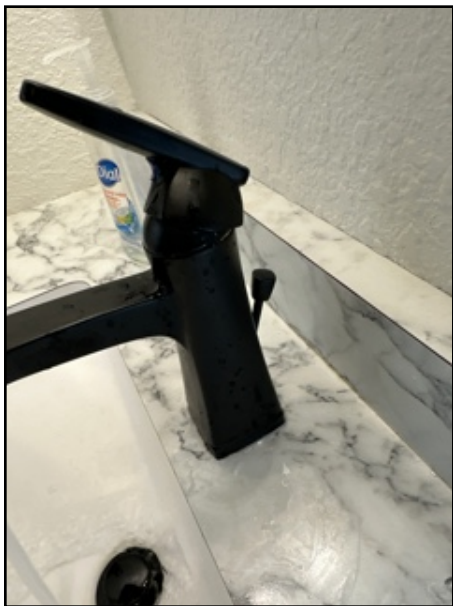
Figure 21-1

6) Sink faucet leaks around stem. Allows water to run to back of countertop

**Comment 21:**  
Sink faucet leaks around stem. Allows water to run to back of countertop

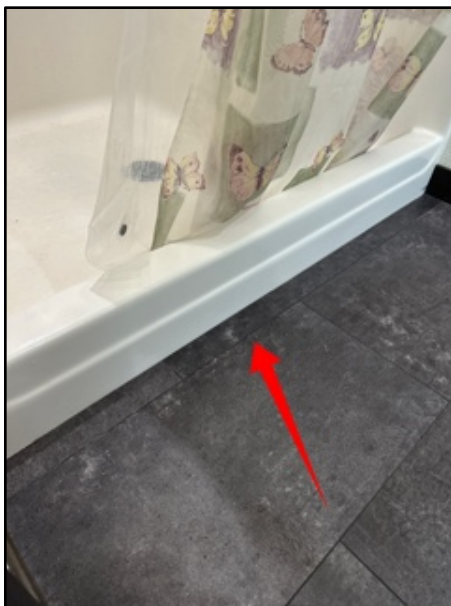
Figure 23-1

Comment 23:  
Caulk missing at shower to flooring transition.

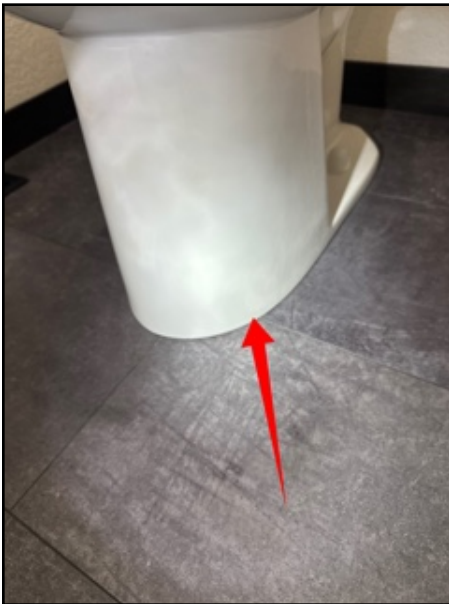
Figure 24-1

Toilet should be caulked around base.

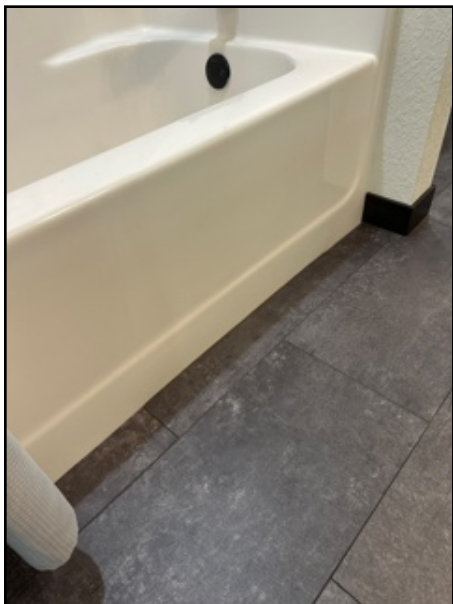
Figure 25-1

Caulk/grout around tub/shower needs repair/replacement.

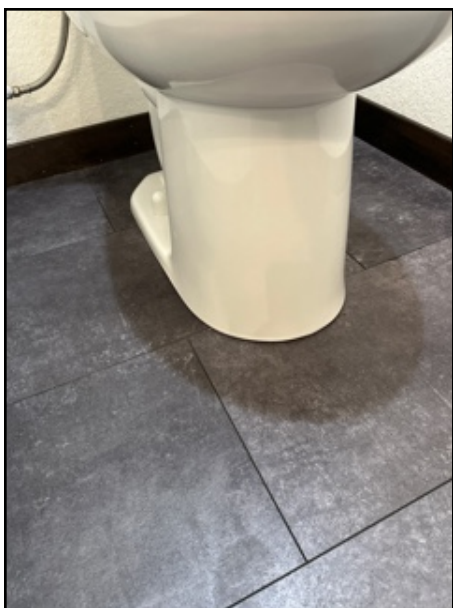
Figure 26-1

Toilet should be caulked around base.

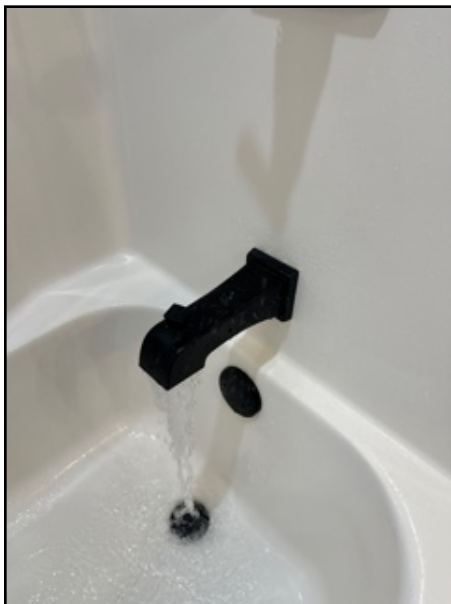
Figure 27-1

Comment 27:  
Tub spout is loose .

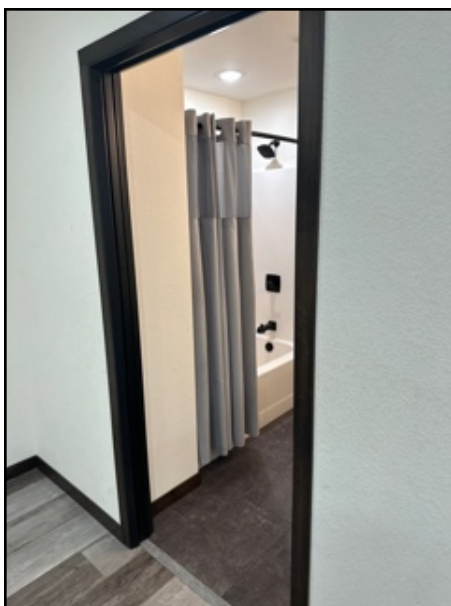
Figure 28-1

Comment 28:  
Pocket door can be difficult to close and lacks a lock .

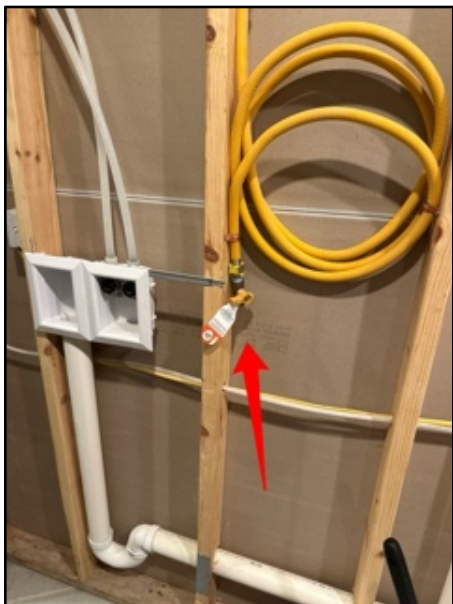
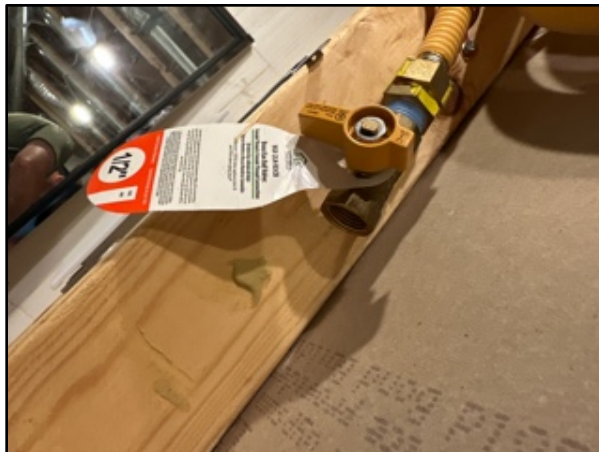
7) Gas line not in use should be securely capped to avoid accidental leakage .

Gas line not in use should be securely capped to avoid accidental leakage .

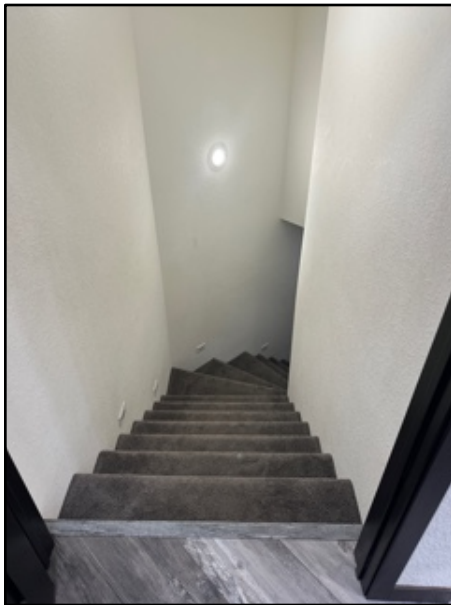
Figure 32-1

8) Missing handrail on staircase.

Comment 32:  
Missing handrail on staircase.

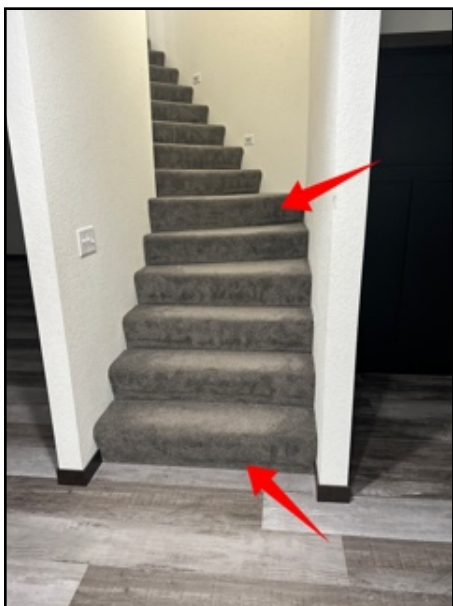
Figure 33-1

9) Two stair risers are taller than all others by about an inch. This can be a trip hazard

Two stair risers are taller than all others by about an inch. This can be a trip hazard

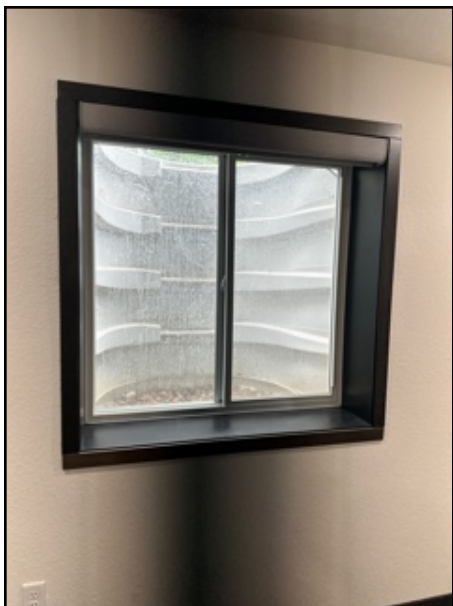
Figure 34-1

Missing window screen.

Windows dirty. Likely due to sprinklers.

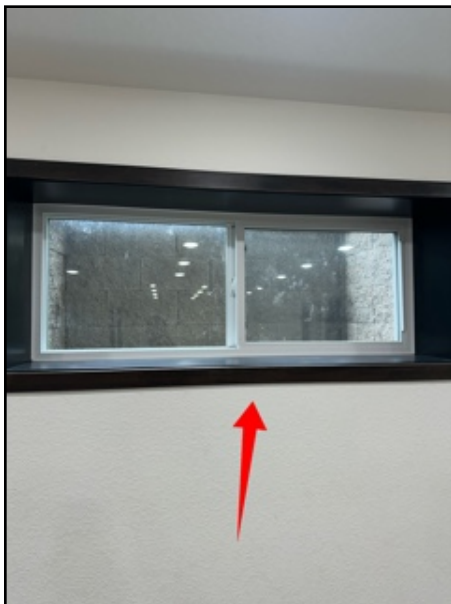
Figure 35-1

Comment 35:  
Sill bowed. Window frame bowed up in center.

Also damaged screen
